**Flood Control Project Maintenance  
Levee Inspections**  
**LMA District Cover Sheet**  
**Spring 2017 Levee Inspection Results**

**Reclamation District No. 0010 Honcut**

**Spring 2017 Levee Inspection Results**

Waterway			Bank	Unit Miles
Unit No. 01 Simmerly Slough			Right	7.65
	Spring (March - May)	Summer (June - August)	(September - November) Fall	Winter (December - February)
Unit Maintenance Rating (Fall Only)				
Date of Inspection	4/11/2017 - 4/11/2017			
DWR Inspector	Sterling York			
Accompanied By	Finlay Williams

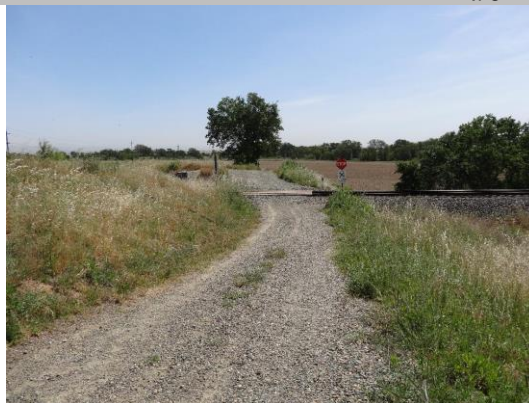
Photo 1 of 3 : UCIP\_SP\_2017\_27791\_51501.jpg

LM Start	0.00	Rating **	M	Issue No.	68
LM End	0.00	Issue Type +	Ma	Location *	N/A
Category	Supplemental			GPS Latitude/Longitude	
				Start	End
Item	DWR UCIP LMA Responsibility			39.169234 °	39.169234 °
				-121.586203 °	-121.586203 °
DWR ID					
Comment Code					
Inspector Comment					
FS_ID:27791 DS_ID:21268 EP_NO: N/A Repair Type: Non-Urgent Crossing Status: Found UCIP Comments: Vegetation has been cleared from slope. This crossing is referenced in the USACE Periodic Inspection as item USACE_CESPK_HON1_2013_p_0158. FIELD_STRUCT_DESC: 24-inch CM drainpipe through the levee, 30.0 feet below the crown. Flap gate on the waterward end. Slide gate on the landward end. Concrete saddle and apron on waterward side. (USACE-1955). This entry matches the Drainage or Irrigation Structure referenced in O&M manual (Station 1+00). FS Date: 4/29/2013

View of levee crown looking downstream.

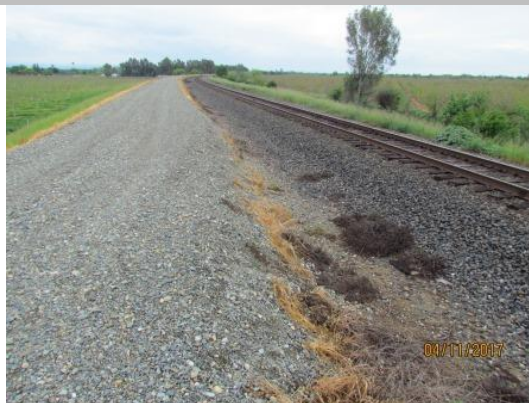
Photo 1 of 1 : SP\_2017\_RD0010\_163\_31\_20170425\_00098.jpg

LM Start	0.00	Rating **	M	Issue No.	29
LM End	1.62	Issue Type +	Ma	Location *	LS
Category	Earthen Levee			GPS Latitude/Longitude	
				Start	End
Item	Vegetation			39.163718 °	39.169305 °
				-121.609935 °	-121.585804 °
DWR ID	DWR_RD0010_01_s_2017_29				
Comment Code					
V1 : Control annual grass and weeds on the levee slopes and easements.					
Inspector Comment					
Annual grass need to be maintained, the shoulder and partial top of slope has been sprayed, Spring 2017.

View of well maintained annual grasses on the waterside, Spring 2017.

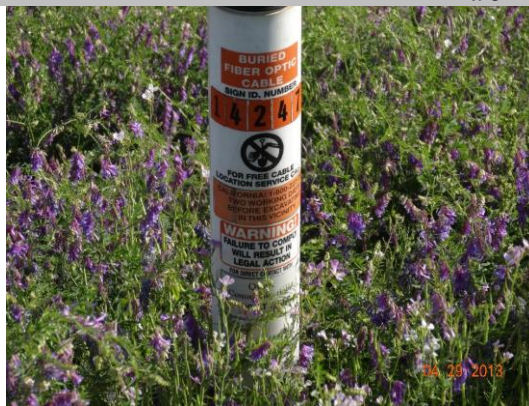
Photo 1 of 2 : UCIP\_SP\_2017\_27712\_51365.jpg

LM Start	0.23	Rating **	M	Issue No.	69
LM End	0.23	Issue Type +	En	Location *	WS
Category	Supplemental			GPS Latitude/Longitude	
				Start	End
Item	DWR UCIP Field Study			39.163407 °	39.163407 °
				-121.605645 °	-121.605645 °
DWR ID					
Comment Code					
Inspector Comment					
FS_ID:27712 DS_ID:24653 EP_NO: N/A Repair Type: Non-Urgent Crossing Status: Indicator Found UCIP Comments: Need to contact owner--unable to determine if crossing is authorized (no permit found) also need to determine if crossing goes through levee. FIELD_STRUCT_DESC: Fiber optic line markers on levee slope unable to determine if line goes through levee. FS Date: 4/29/2013

Contact information for buried fiber optic cable.

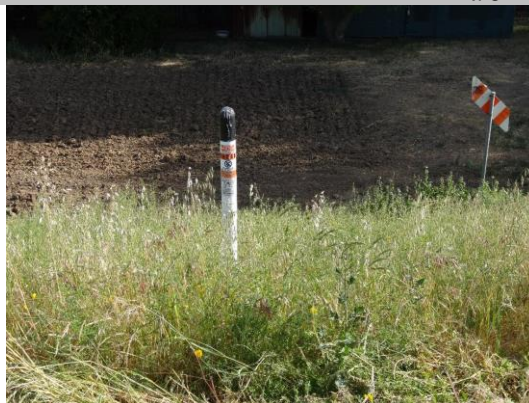
Photo 1 of 2 : UCIP\_SP\_2017\_27713\_51366.jpg

LM Start	0.41	Rating **	M	Issue No.	71
LM End	0.41	Issue Type +	En	Location *	WS
Category	Supplemental			GPS Latitude/Longitude	
				Start	End
Item	DWR UCIP Field Study			39.162853 °	39.162853 °
				-121.602435 °	-121.602435 °
DWR ID					
Comment Code					
Inspector Comment					
FS_ID:27713					
DS_ID:24654					
EP_NO: N/A					
Repair Type: Non-Urgent					
Crossing Status: Indicator Found					
UCIP Comments: Need to contact owner--unable to determine if crossing is authorized (no permit found) also need to determine if crossing goes through levee.					
FIELD_STRUCT_DESC: Fiber optic line markers on levee slope unable to determine if line goes through levee.					
FS Date: 4/29/2013

View of landward side--communication line marker.

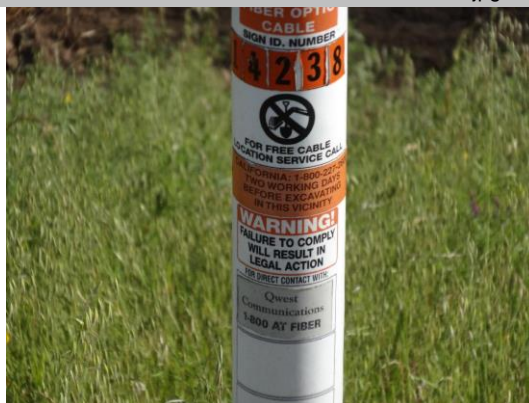
Photo 2 of 2 : UCIP\_SP\_2017\_27713\_51367.jpg

Contact information for communication line.

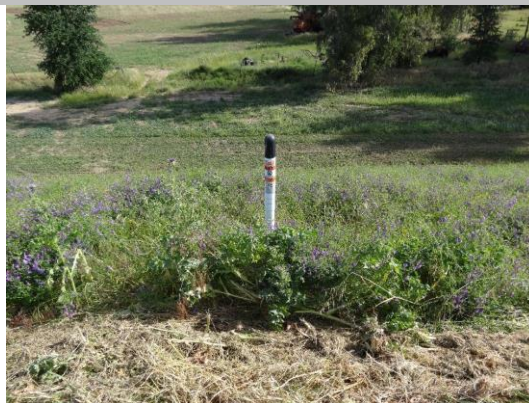
Photo 2 of 2 : UCIP\_SP\_2017\_27710\_51360.jpg

FS\_ID:27710  
DS\_ID:24655  
EP\_NO: N/A  
Repair Type: Non-Urgent  
Crossing Status: Indicator Found  
UCIP Comments: Need to contact owner--unable to determine if crossing is authorized (no permit found) also need to determine if crossing goes through levee.  
FIELD\_STRUCT\_DESC: Fiber optic line markers on levee slope unable to determine if line goes through levee.  
FS Date: 4/29/2013

View of marker located on landward side.

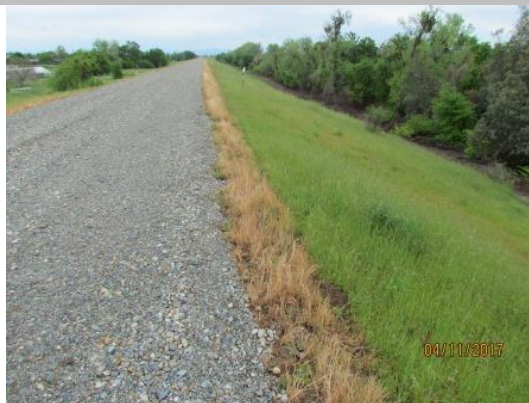
Photo 1 of 1 : SP\_2017\_RD0010\_163\_30\_20170425\_00094.jpg

View looking upstream of the annual grass that need to be maintained, the shoulder has been sprayed. Spring 2017.

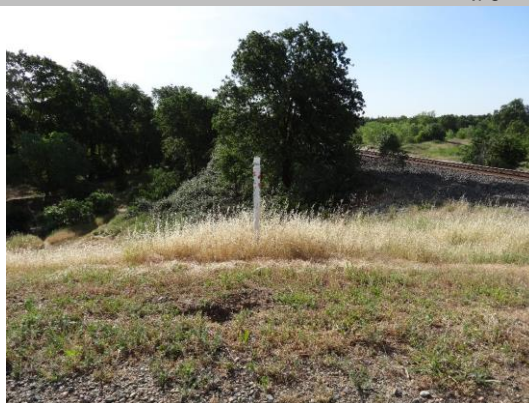
Photo 1 of 2 : UCIP\_SP\_2017\_27715\_51371.jpg

LM Start	0.72	Rating **	M	Issue No.	73
LM End	0.72	Issue Type +	En	Location *	WS
Category	Supplemental			GPS Latitude/Longitude	
				Start	End
Item	DWR UCIP Field Study			39.161229 °	39.161229 °
				-121.597072 °	-121.597072 °
DWR ID					
Comment Code					
Inspector Comment					
FS_ID:27715					
DS_ID:24656					
EP_NO: N/A					
Repair Type: Non-Urgent					
Crossing Status: Indicator Found					
UCIP Comments: Need to contact owner--unable to determine if crossing is authorized (no permit found) also need to determine if crossing goes through levee.					
FIELD_STRUCT_DESC: Fiber optic line markers on levee slope unable to determine if line goes through levee.					
FS Date: 4/29/2013

View of marker located on waterward side.

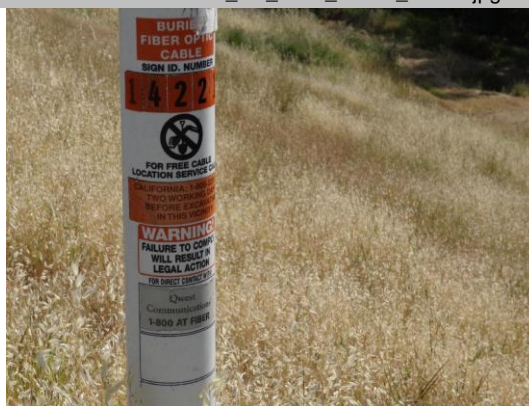
Photo 2 of 2 : UCIP\_SP\_2017\_27715\_51370.jpg

LM Start	0.72	Rating **	M	Issue No.	73 (cont)	
LM End	0.72	Issue Type +	En	Location *	WS	
Category	Supplemental			GPS Latitude/Longitude		
				Start	End	
Item	DWR UCIP Field Study			39.161229 °	39.161229 °	
				-121.597072 °	-121.597072 °	
DWR ID						
Comment Code						
Inspector Comment						
FS_ID:27715						
DS_ID:24656						
EP_NO: N/A						
Repair Type: Non-Urgent						
Crossing Status: Indicator Found						
UCIP Comments: Need to contact owner--unable to determine if crossing is authorized (no permit found) also need to determine if crossing goes through levee.						
FIELD_STRUCT_DESC: Fiber optic line markers on levee slope unable to determine if line goes through levee.						
FS Date: 4/29/2013

Contact information and ID number for buried fiber optic cable.

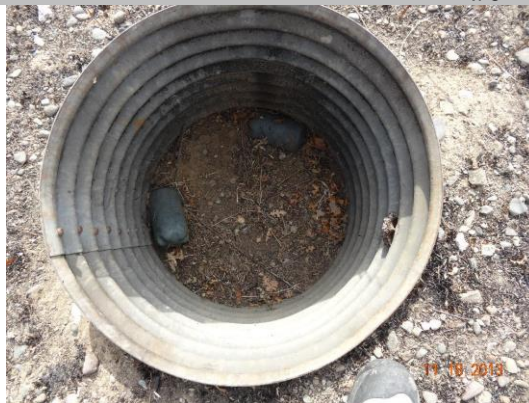
Photo 3 of 3 : UCIP\_SP\_2017\_24810\_44575.jpg

Comment Code						
Inspector Comment						
FS_ID:24810 DS_ID:21263 EP_NO: N/A Repair Type: Non-Urgent Crossing Status: Found UCIP Comments: Pipe has been capped on waterward side--see photos. Need to coordinate with DWR Inspector to determine whether crossing is compliant with Title 23. This crossing is referenced in the USACE Periodic Inspection as item USACE_CESPK_HON1_2013_p_0016. FIELD_STRUCT_DESC: 10-inch steel pipe through the levee, 6.8 feet below the crown. Steel cutoff plate around pipe at center of levee. Siphon breaker in CM riser on the waterward slope. Pump on concrete base on the waterward berm-not present. 36-inch concrete standpipe at the landward toe. Metal shed and service pole on the waterward slope-not present. (USACE-1955). This entry matches the Drainage or Irrigation Structure referenced in O&M manual (Station 14+16). FS Date: 4/29/2013

Siphon breaker has been buried inside CMP riser.

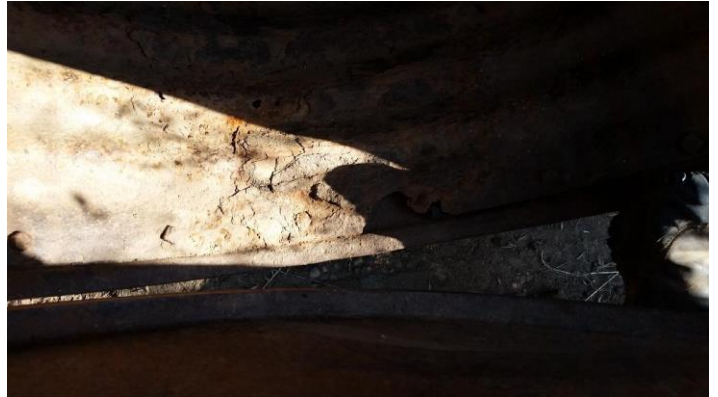
Photo 3 of 3 : UCIP\_SP\_2017\_49986\_75321.jpg

Deteriorated pipe wall at the outlet (WS).

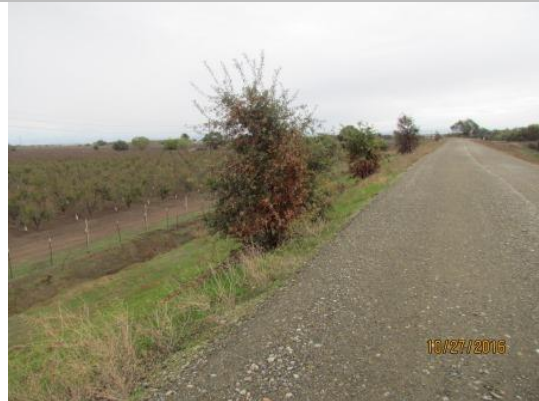
Photo 1 of 1 : SP\_2017\_RD0010\_163\_67\_20170316\_00034.jpg

View of a small tree that needs to be removed on the land side slope looking upstream. Fall 2016.

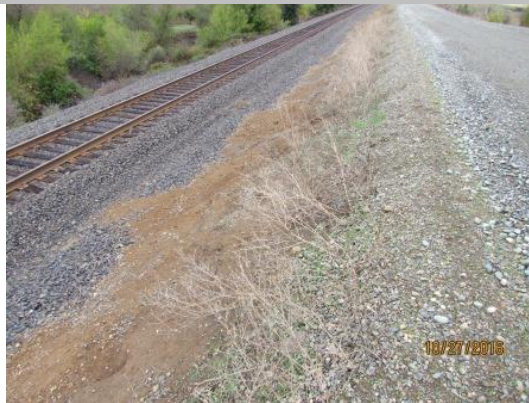
Photo 1 of 1 : SP\_2017\_RD0010\_163\_60\_20170316\_00028.jpg

View of squirrel holes on the landside slope and toe, no rodent activity was observed. Fall 2016.

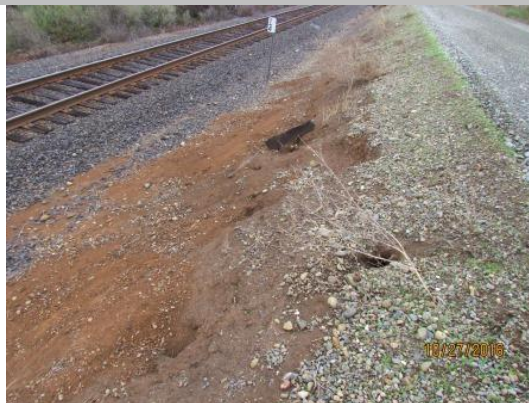
Photo 1 of 1 : SP\_2017\_RD0010\_163\_57\_20170316\_00025.jpg

View of squirrel holes on the landside slope and toe, no rodent activity was observed. Fall 2016.

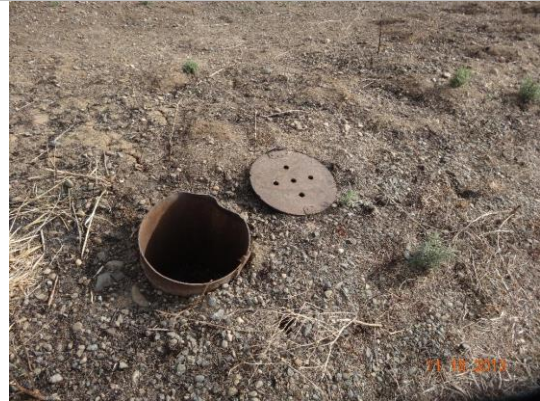
Photo 2 of 3 : UCIP\_SP\_2017\_49987\_44605.jpg

View of riser with damage lid located on WS shoulder.

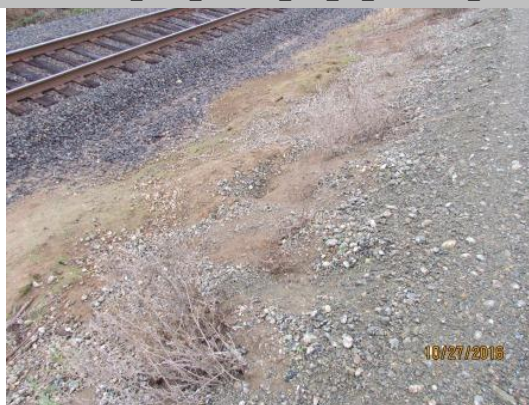
Photo 1 of 1 : SP\_2017\_RD0010\_163\_50\_20170316\_00020.jpg

View of squirrel holes on the landside slope and toe, no rodent activity was observed. Fall 2016.

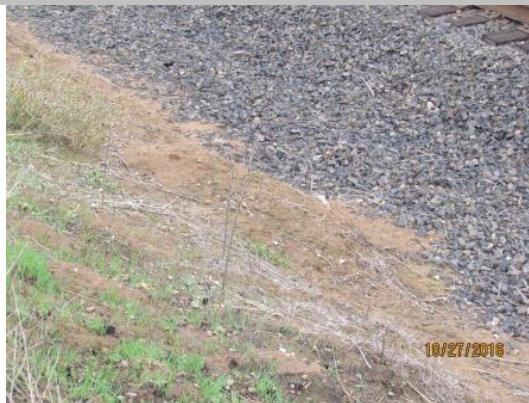
Photo 1 of 1 : SP\_2017\_RD0010\_163\_46\_20170316\_00015.jpg

View of squirrel holes on the landside slope and toe, no rodent activity was observed. Fall 2016.

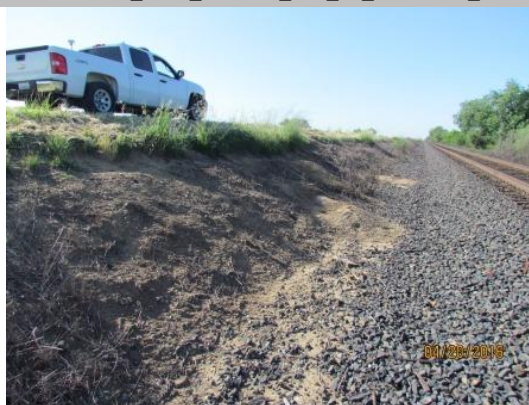
Photo 1 of 1 : SP\_2017\_RD0010\_163\_41\_20170316\_00012.jpg

View of multiple active ground squirrel holes on landside slope looking downstream.

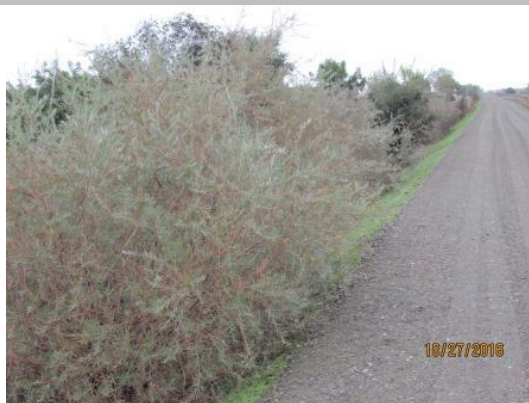
Photo 1 of 1 : SP\_2017\_RD0010\_163\_40\_20170316\_00011.jpg

View of willow trees on the landside slope looking upstream. Fall 2016.

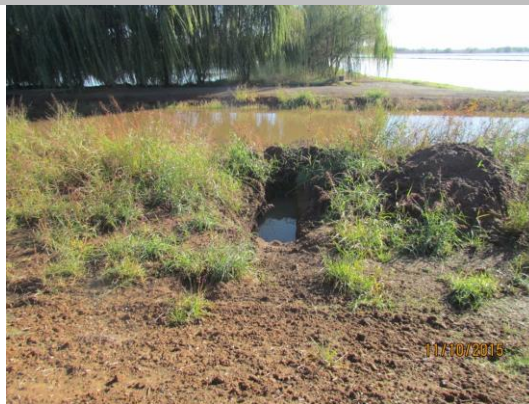
Photo 1 of 4 : SP\_2017\_RD0010\_163\_27\_20170316\_00001.jpg

The trench is dug by the farmer for a pipe. Fall 2015.

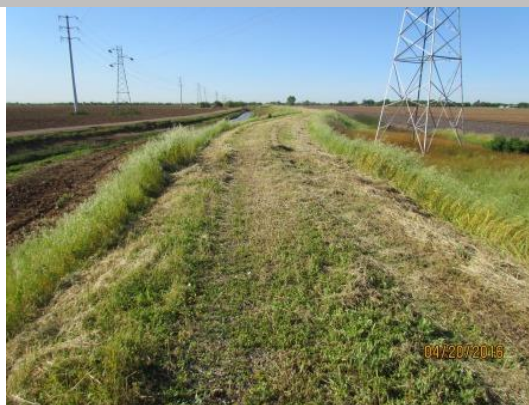
Photo 3 of 4 : SP\_2017\_RD0010\_163\_27\_20170316\_00003.jpg

View of depression in crown, caused by an unpermitted pipe crossing. A FIR was created for this issue. Spring 2016.

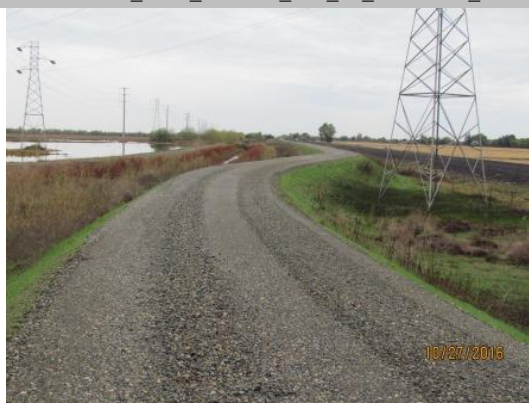
Photo 4 of 4 : SP\_2017\_RD0010\_163\_27\_20170316\_00004.jpg

View of where the depression was caused by the pipe installation. The depression no longer exist due to the grading and new rock that was added to the crown, looking downstream. Fall 2016.

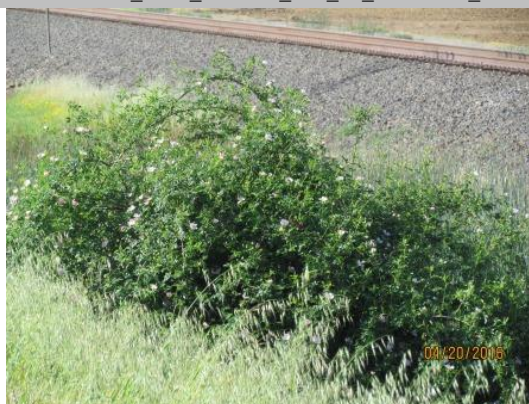
Photo 1 of 1 : SP\_2017\_RD0010\_163\_34\_20170316\_00008.jpg

View of thick wild rose bush that obstructs visibility of the landside slope and toe. Spring 2016.

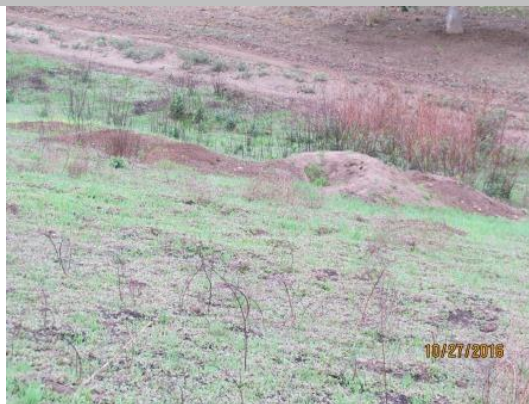
Photo 1 of 1 : SP\_2017\_RD0010\_164\_30\_20170316\_00009.jpg

View of rodent hole that has more than 2 cubic feet of material on the waterside.

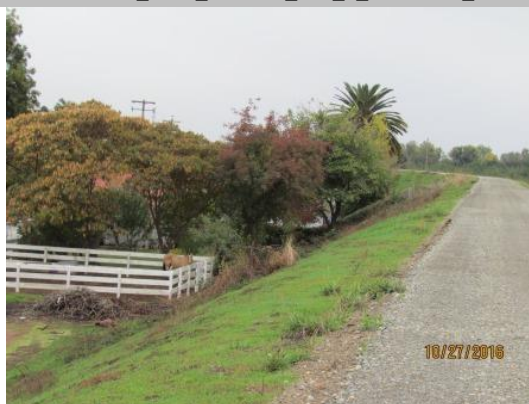
Photo 1 of 1 : SP\_2017\_RD0010\_164\_9\_20170316\_00005.jpg

View of homeowners landscaping and fence that encroaches on the landside levee slope, looking downstream.

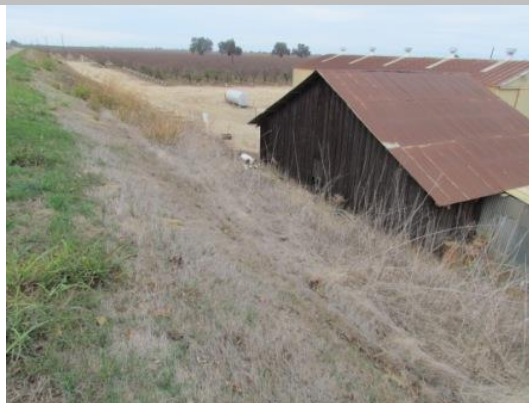
Photo 1 of 1 : SP\_2017\_RD0010\_164\_65\_20170316\_00030.jpg

This photo was taken from the crown facing north looking down the landward levee slope at an outbuilding near the levee toe.

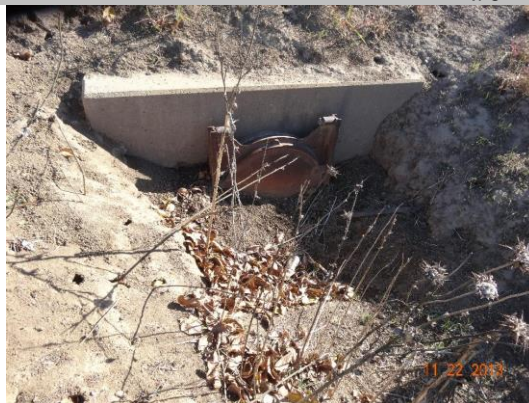
Photo 3 of 3 : UCIP\_SP\_2017\_24825\_44662.jpg

Flap gate located on waterward side--debris blocking gate.

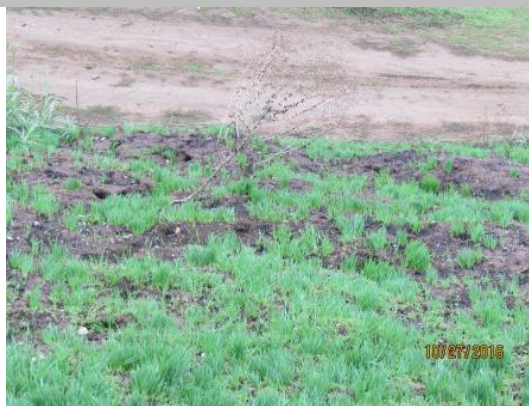
Photo 1 of 1 : SP\_2017\_RD0010\_164\_68\_20170316\_00033.jpg

View of rodent holes on waterside slope, no evident of rodent activity Spring 2017.

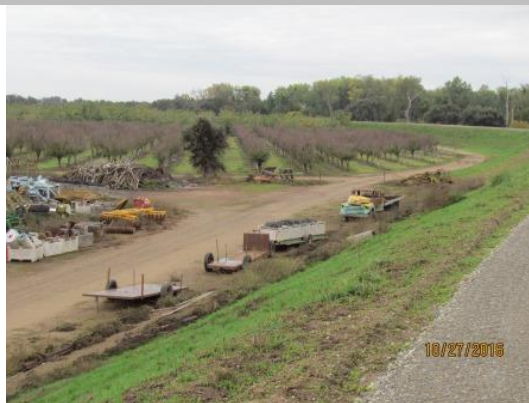
Photo 2 of 2 : SP\_2017\_RD0010\_164\_31\_20170316\_00011.jpg

View of the equipment at the toe of the levee on the landward side of the levee looking downstream.

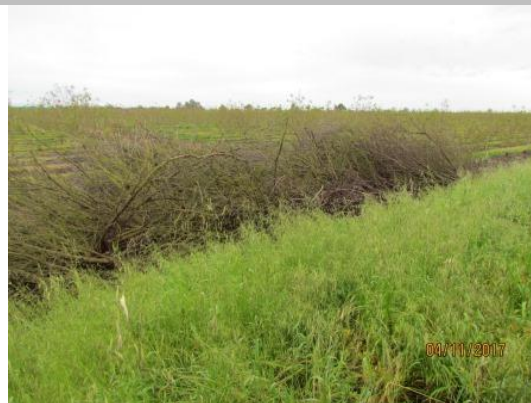
Photo 1 of 1 : SP\_2017\_RD0010\_164\_45\_20170414\_00112.jpg

View of pruning's piled on the levee toe, Spring 2017.

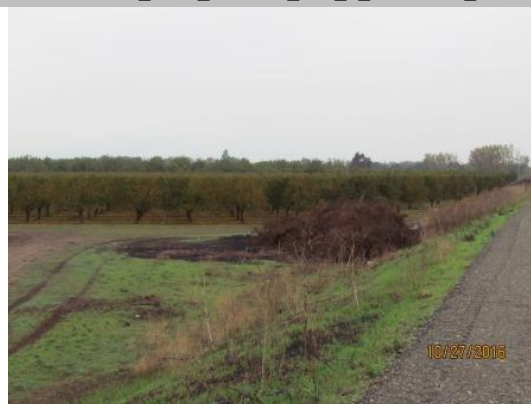
Photo 1 of 1 : SP\_2017\_RD0010\_165\_7\_20170316\_00002.jpg

View of pruning's at landside levee toe looking downstream.
